# **Road Commission for Oakland County PHB and RRFB Study**

## **Final Report**

**Department of Blindness and Low Vision Studies  
Western Michigan University,**

October 5, 2011

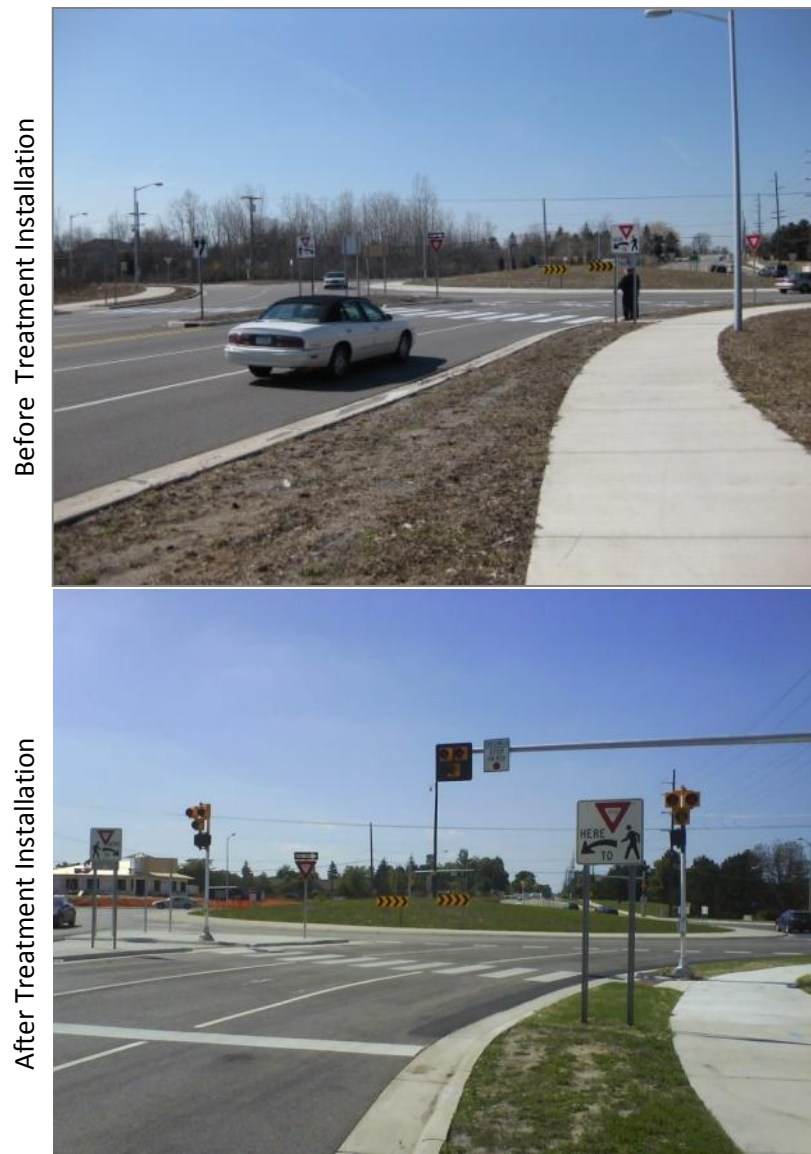
**Figure 7: Pretest and Posttest Photos of PHB Treatments at Maple and Drake Roundabout**

Each roundabout crosswalk was outfitted with a Pedestrian Hybrid Beacon (PHB), which is also commonly referred to as a HAWK (High-intensity Activated crossWalk) beacon. In total, eight independent PHBs were installed (entry and exit at all four approaches), although only four PHBs were evaluated in this study. Figure 7 shows photographs of the three-lane approach before and after treatment installation (view looking west along Maple Road, roundabout entry lanes). More photographs of the roundabout before and after treatment installation are shown in a photo log include as Appendix A of this report.

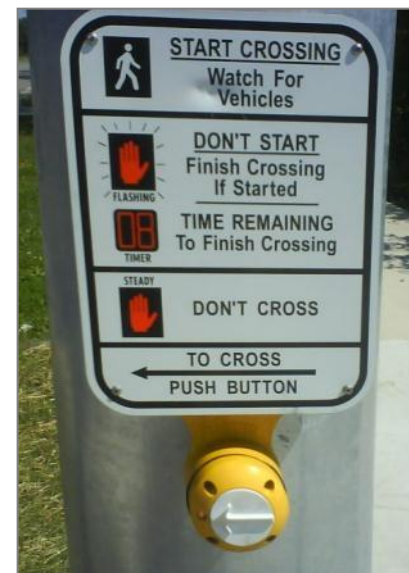
**Figure 1: Photo of APS Installation**

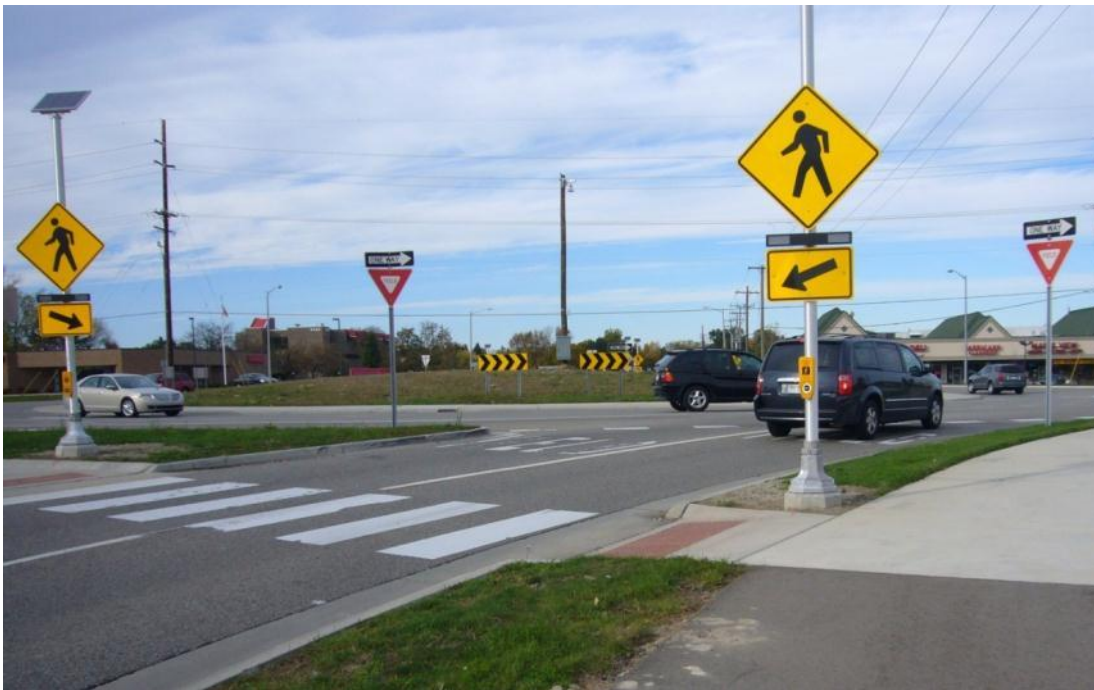
**Figure 9: Photo of the RRFB Installation at the Maple/Farmington Three-Lane Entry**

The RRFBs at the roundabout were installed and wired in a manner that allowed all eight legs (entry and exit) at the four approaches to operate independently. RRFBs consist of two rectangular rapidly flashing amber LED lights. All RRFBs rested in the "dark" display for vehicular traffic and the pedestrian movement, and were activated by pushbuttons. When the button was pushed, the lights began to flash for both beacons in the pair (communication between the button and the RRFB itself was wireless). In addition, when the lights began to flash, a message was played for the pedestrians stating: "The yellow lights are flashing". The RRFB remained active for 20 seconds, after which it returned to "dark" mode. When activated, the two amber indications flash rapidly in an alternating flashing sequence (left light on, then right light on). The rate of flashing of the two yellow LEDs varied from 70 to 80 flashes per minute. Each flashing light had alternating but approximately equal periods of rapid pulsing light emissions and dark operation. Figure 8 shows a picture of RRFB. More photographs of the roundabout before and after treatment installation are shown in a photo log include as Appendix A of this report. The appropriate driver behavior upon RRFB activation is to yield to the pedestrian if there is a pedestrian standing at the crosswalk, although drivers have no legal obligation to yield merely due to the activation of the beacon. Drivers are allowed to proceed through the crosswalk if pedestrians have finished crossing but the RRFB is still active.

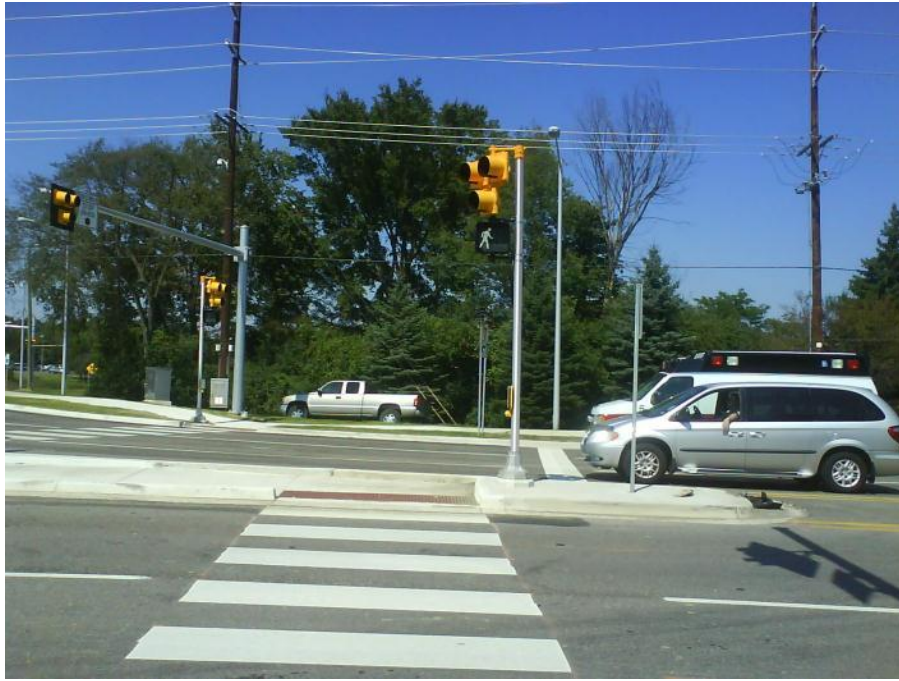
**Figure 38: View of Three-Lane Entry and Exit Legs at Maple Rd. at Maple at Drake Roundabout. After PHB Installation and Crosswalk Relocation (Zigzag) at Exit Leg**

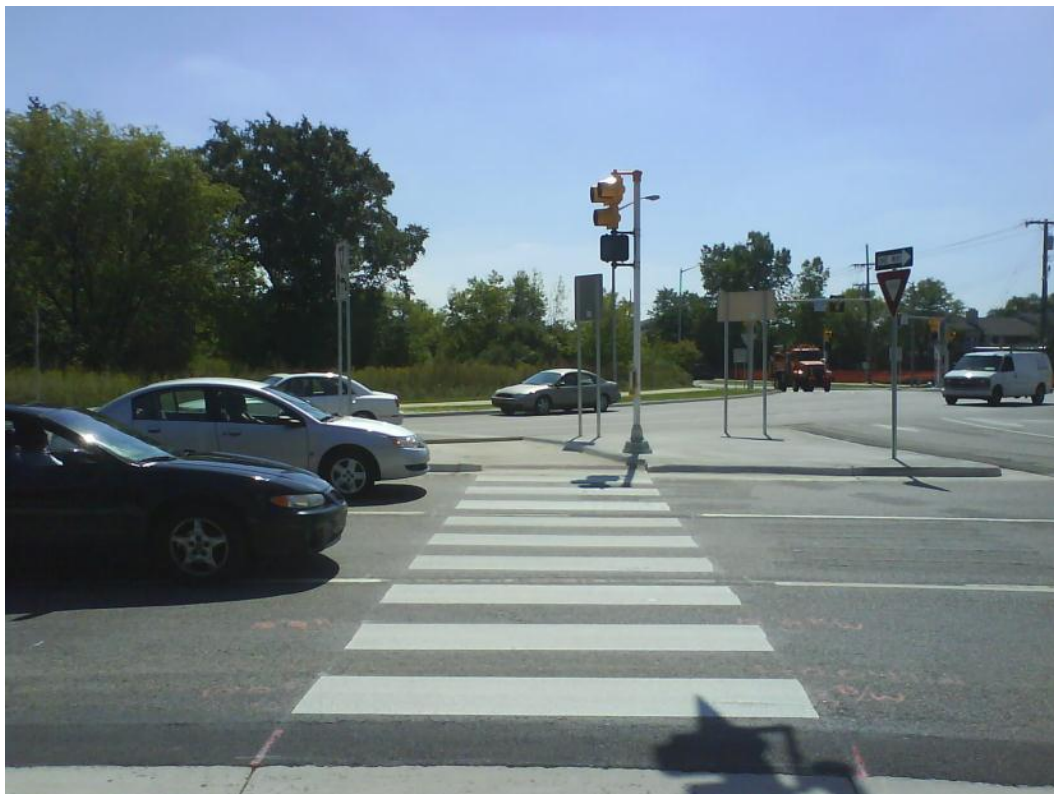
Figure 41: View of Three-Lane Entry at Maple Rd. with Two-Stage Pedestrian Crossing, Maple at Drake Roundabout After PHB Installation

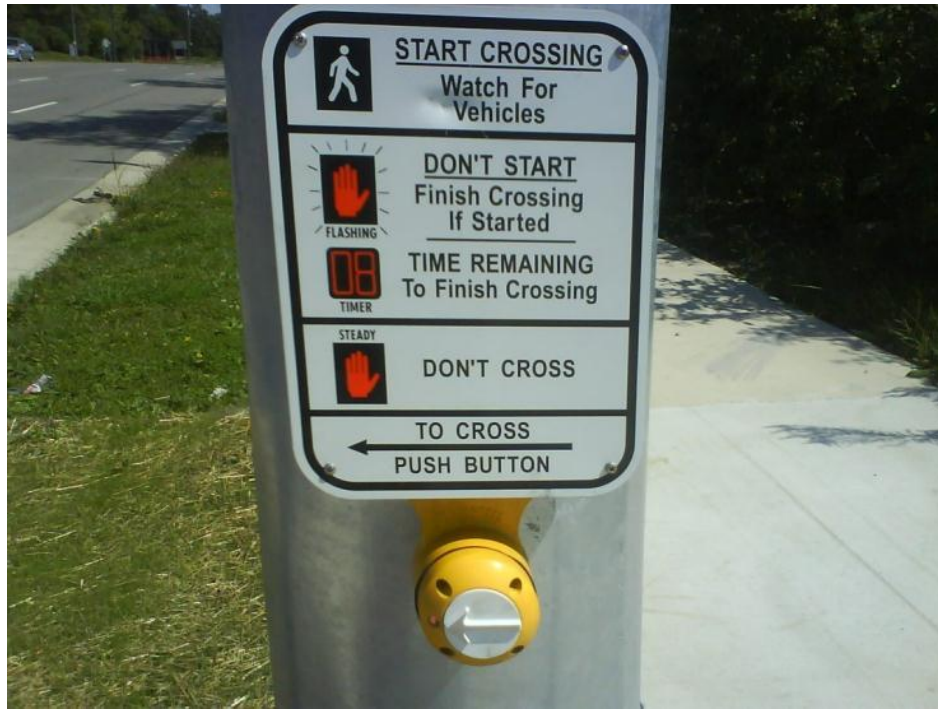
**Figure 42: View of PHB (Audible) Accessible Pedestrian Pushbutton at Maple at Drake Roundabout, After PHB Installation**

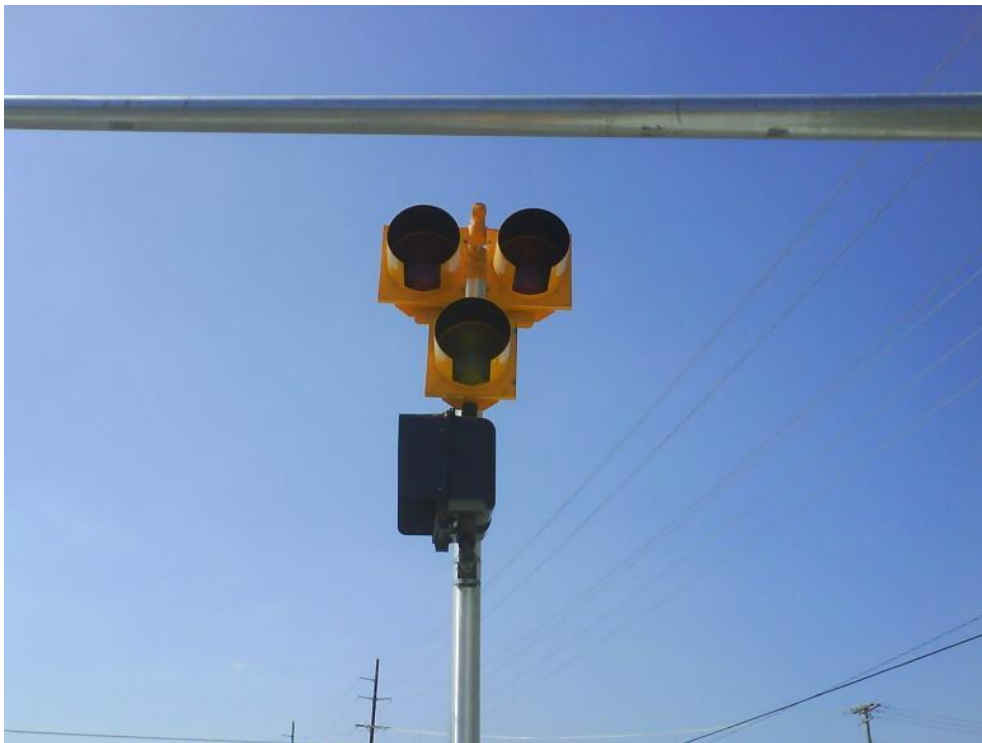
**Figure 43: Close-up View of PHB at Maple at Drake Roundabout**

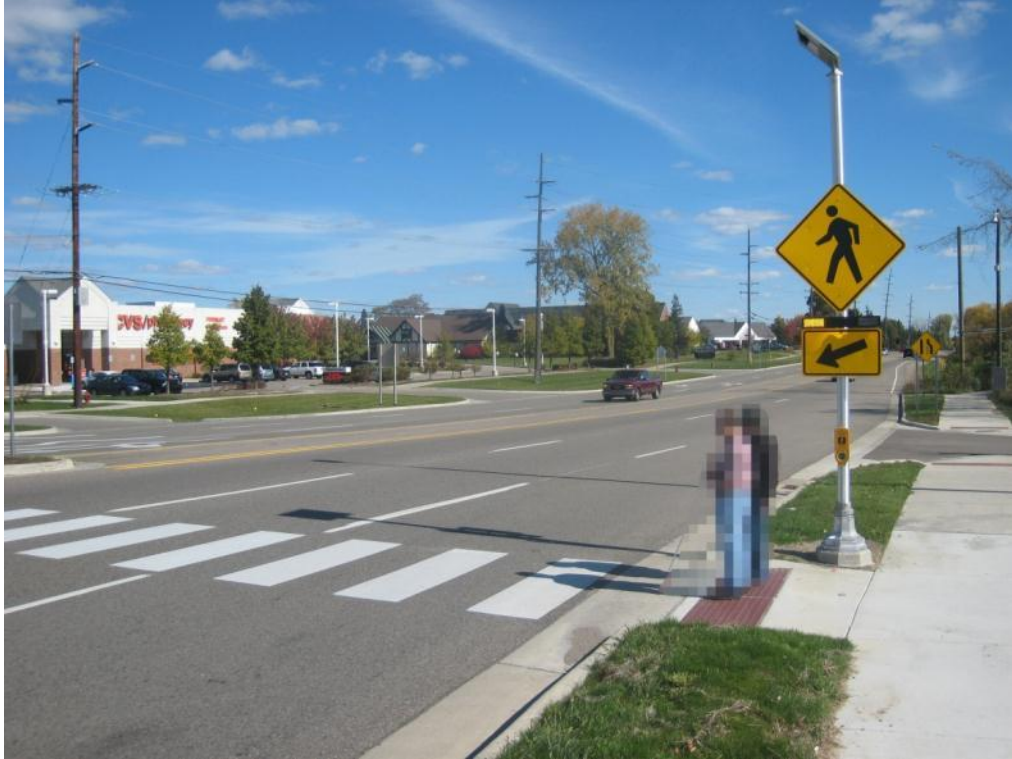
Figure 54: View of RRFB Flashing at Exit Leg Maple Rd. at Maple at Farmington Roundabout

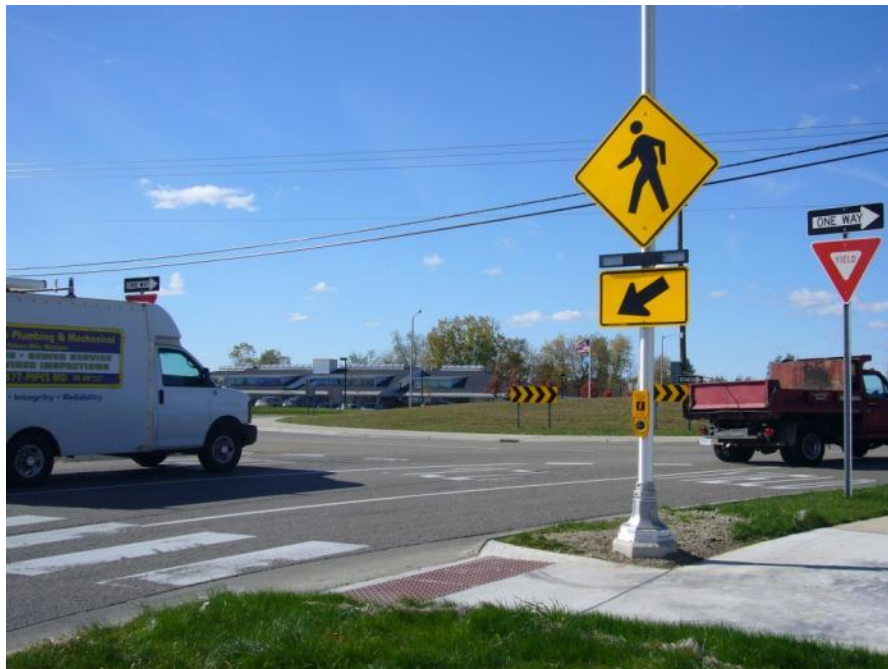
Figure 55: Close-up View of RRFB installed at Entry leg of Maple Rd. at Maple at Farmington Roundabout
